Assessment of Paint Layers Quality

3. Analysis by SEM-EDAX and XRF techniques of the paint layers applied on a railway bridge

In order to identify the premature biodegradation causes of paint applied in 2013 on a railway bridge, top coat layers applied have been investigated by XRF and SEM-EDAX techniques after 32 years, corresponding to periods of operation under identical climatic conditions of 4.5 years and 3.5 years respectively. By analysis of the experimental results obtained, it has been found that by using suitable painting materials (titanium content of about 7.5 % - TiO_2 for UV protection) an exploitation period of more than 30 years could be obtained. Low-carbon (low polymer) and titanium dyeing materials with significant content of soluble salts have a low durability and anticorrosive protection capability. They degrade relatively fast both by top coat degradation and by intense increases of biofouling.

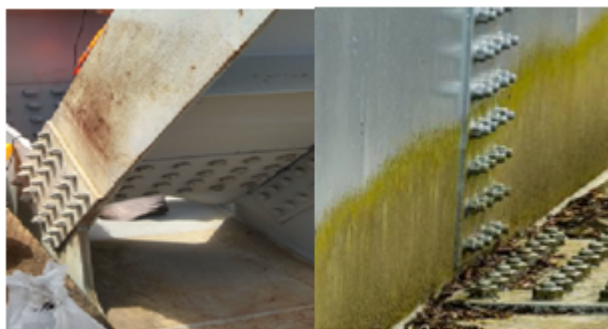
After the first corrosion germs appear under the paint layer the process is substantially accelerated - firstly in the joining zones (screws, welds, etc., fig. 1 and fig. 2), mechanical stress concentrators [26], which causes the metal structure to crash/ to collapse, to additional stresses [26, 27].

Fig. 1. The paint layers degradation at joints of a railway bridge [23]

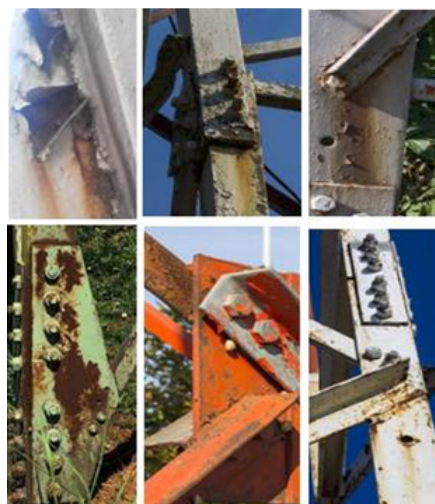
Fig. 2. The paint layers degradation at the joints of an electric line support pillar - local corrosion cell formation [26]

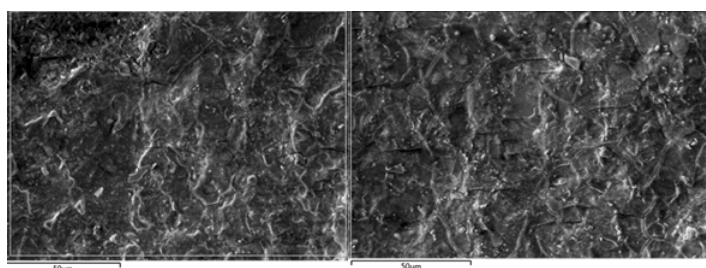
By comparative analysis of the figures 3 - 5, it is observed that the morphostructural structure investigated of the paint samples differs depending of the sampling site, respectively the painting material quality and the exposure duration of the paint layers to the specific stress factors of the operating conditions. The paint applied in 2014 (fig. 5) has a continuous, evenness appearance in which dust particles of the addition material are distinguished, unlike the paint applied in 2013 (fig. 3) which shows numerous cracks / fractures and pronounced unevenness. Thus, the biofouling fixation reported in [23] can be explained.

Fig. 3. SEM images representative of the paint samples taken from the Eastern section of bridge

- the material used in 2013, after only 4.5 years of operation, has shown signs of ageing (it has both unevenness and pronounced asperities and cracks on the surface), which is explained by the relatively low content of titanium (1.1 %) and carbon (48.1 %) - thus, reduced polymer weight in paint) but also by the presence of several atypical elements for painting materials, as 1.1 % chlorine, 0.2 % phosphorus, 1.2 % sodium, 0.9 % potassium and 0.9 % magnesium (elements which give soluble salts and are dissolved from the paint organic matrix);

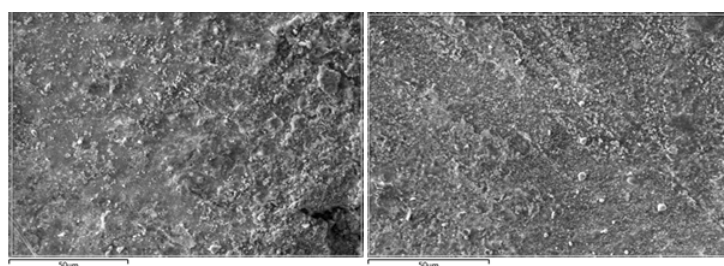
Fig. 4. SEM images representative of the paint samples taken from the central section of bridge

The paint applied in 1986 (fig. 4) has the specific appearance of a coating layer exhibited for a long time (32 years) by atmospheric weathering and solar radiation, respectively, with a continuous appearance (without cracks) but with slight unevenness due to ageing and chalking of the polymer.

- the materials and the coating system used in 1986 with lead-based primer and relatively high titanium content (7.5%), give the first signs of aging by excessive oxidation of the polymer followed de chalking, only after 32 years of operation.

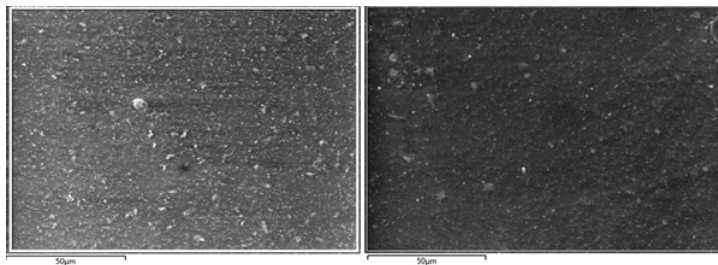
Fig. 5. SEM images representative of the paint samples taken from the Western section of bridge

- the material used in 2014 has a high content in the polymer (carbon 61.2%) and after approx. 3.5 years of exploitation do not show signs of ageing, it has a homogeneous surface without unevenness and/or cracks.

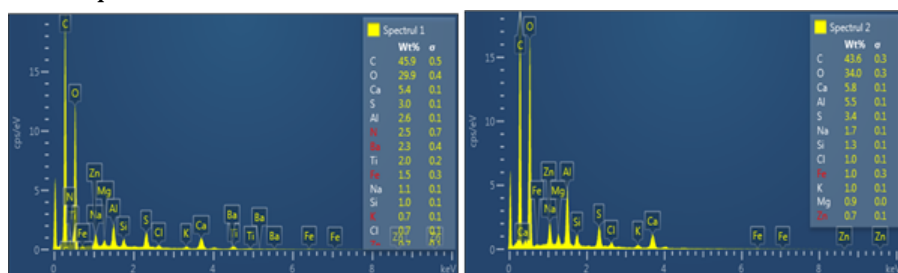
Fig. 6. The representative EDAX spectra for paint samples taken from the Eastern section of bridge

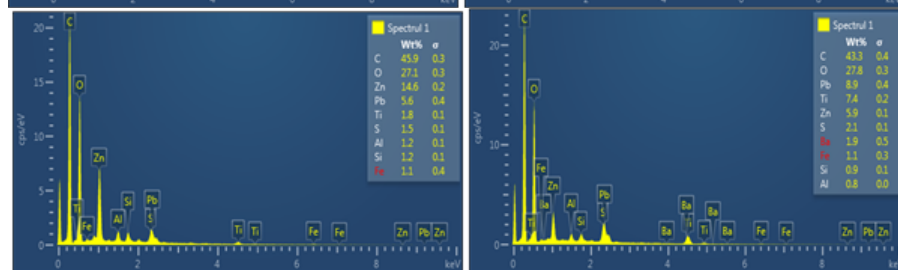
Fig. 7. The representative EDAX spectra for paint samples taken from the central section of bridge

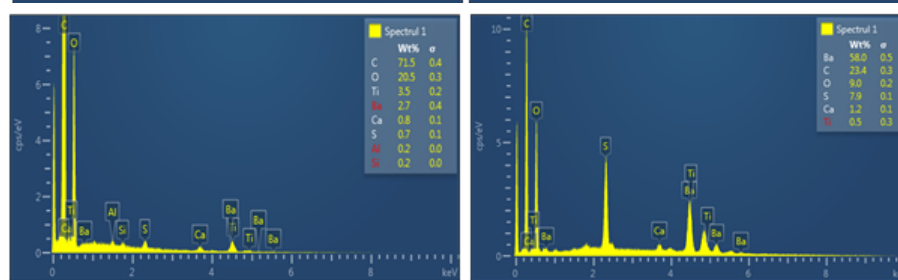
Fig. 8. The representative EDAX spectra for paint samples taken from the Western section of bridge
