# Fractography Study of Explanted Intramedullary Nails

*This study comprises the studies performed on six in vivo failed centromedullary fixation devices, three made of stainless steel 316L and three of titanium alloy Ti-6Al-4V. Fractographic studies were performed using stereomicroscopy and scanning electron microscopy while metallographic studies were performed by light microscopy. Loading mode which caused failure was inferred based upon surface fracture topography and light microscopy studies were performed to observe if abnormal microstructures or inclusions could be the cause of the failure. In all cases the chemical composition was according to standard specifications and the microstructures appeared normal with low inclusionary content. The mode of failure was found to be fatigue and the crack initiation site was on the implant surface on roughness features and surface induced defects.*

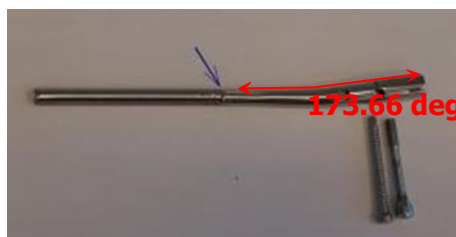
A centro-medullar nail was extracted from a patient after failure according to hospital settled protocol. The catastrophic failure occurred at the middle of the length of the implant, as depicted by Fig. 1.

Fig. 1. Failed Seidel centro-medullar nail explant.  
Arrow points to failure.

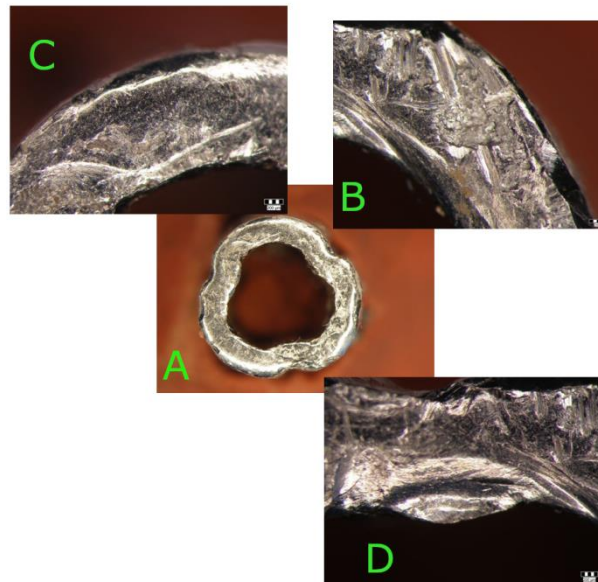
Fig. 3. Images obtained using the stereomicroscope showing fracture surface

In fig. 3.a the general view of the fracture surface is presented, the section shows no deformations, thus no overload can be assumed. Fatigue failure was the failure mechanism culprit, fatigue striations can be seen in fig. 3.b to 3.d, most obvious in the last. Galling is present in fig 3.b, a form of wear between sliding surfaces. Crack growth separated the surfaces and under compressive load some material was pulled with the contacting surface.

In Fig. 3.d a region which resembled to a brittle failure was inferred at this the low magnification. In this area final fracture occurred; the section area was small enough and unable to withstand the applied load.

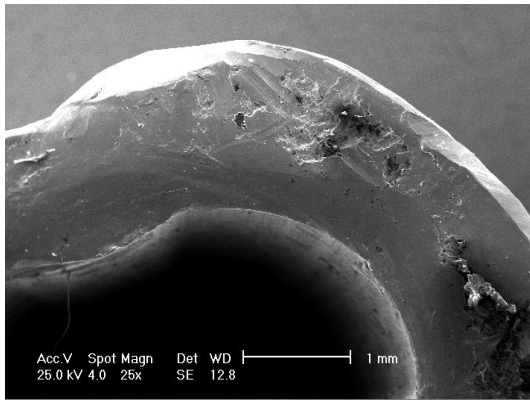
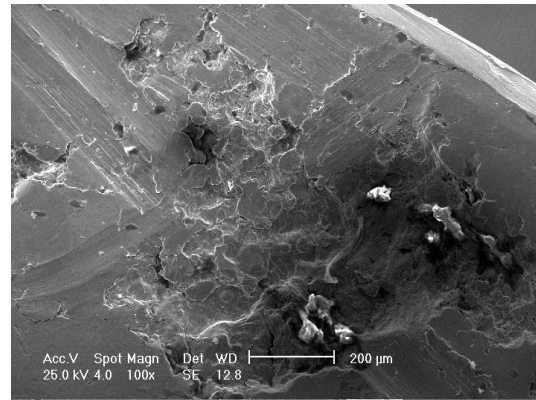
Fig. 4. Scanning electron micrographs showing fracture surface a. general aspects and b. a detail which resembles to tire marks

Fig. 4.a shows a smooth surface typical for crack growth during fatigue and a region with various morphologies where final failure occurred. Higher magnifications used (Fig. 4.b) revealed tool damage caused by the physician in his attempt of implant removal; these marks run on NV-SE and NE-SV directions starting from the edge of the implant.

Unfortunately these marks destroyed most of the features useful for crack origin and growth direction inference.

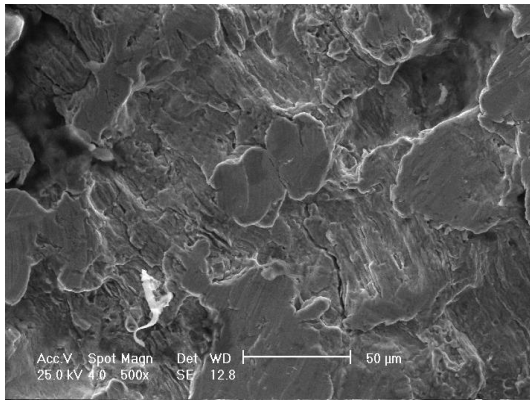
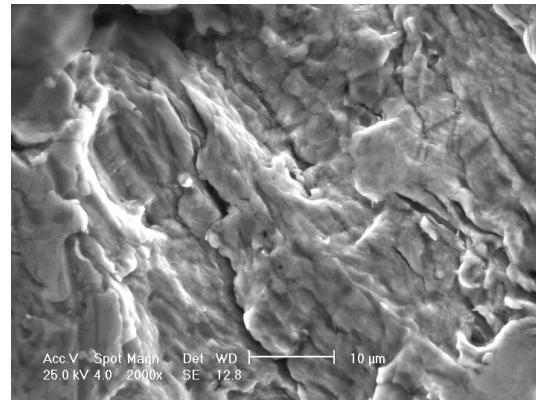
Fig. 5. Scanning electron micrographs showing fracture in a. galling and cleavage fracture and b. cleavage facets and micro-cracks

Fig. 5.a reveals a NV-SE failure direction with galling caused by NE-VS sliding direction. Microscopic cracks are oriented on the same NV-SE direction and in Fig. 5.b, at higher magnifications, crack branching can be observed. The cracks extend on different planes.

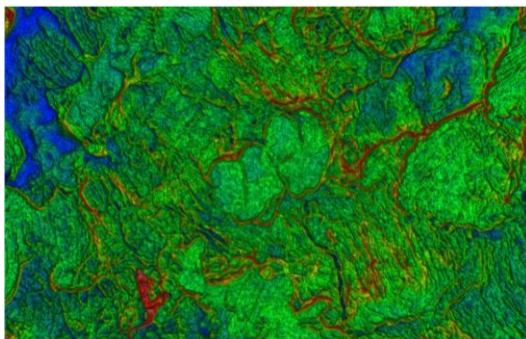
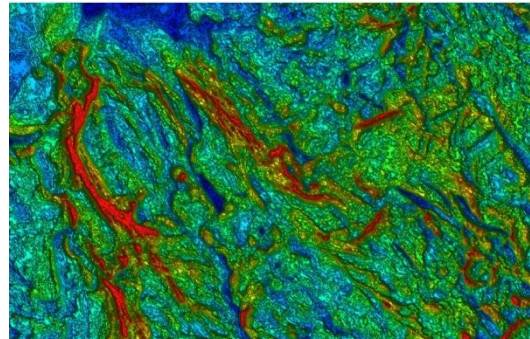
Fig. 6. Artificial height coloring of regions of interest from fig. 5.a and 5.b

Fig. 6 is constructed by an artificial height coloring [20] of the topographic secondary electron scanning electron micrograph. The failure origin can be inferred in the NV region, near implant surface, while main loading mode is assumed to be fatigue in torsion.

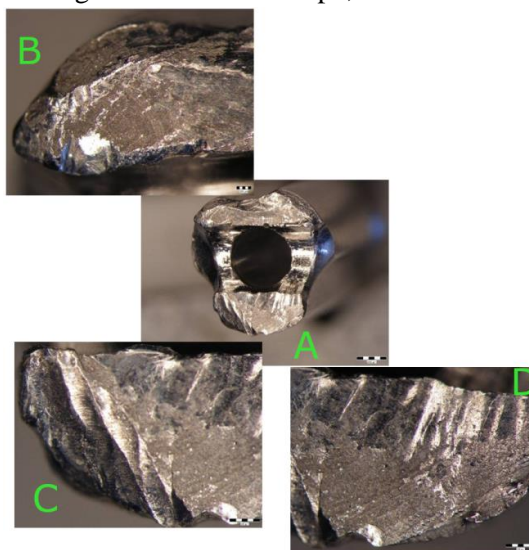
Fig. 9. Fracture surface observed with the stereomicroscope

The fracture aspects depicted in Fig. 9.a suggest a failure in bending, the striations and smooth surface followed by a different fracture morphology observed in Fig. 9 b through d are typical signs of fatigue. The implant failed by fatigue in a bending loading scenario.

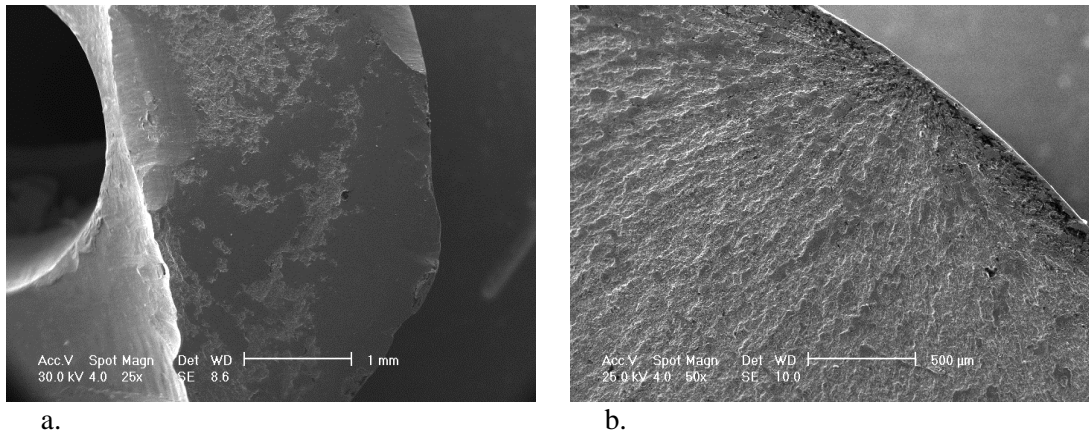
Fig. 10. Fracture surface observed by SEM using secondary electron detector showing a. galling and b. crack growth diverging from crack origin

In Fig. 10.a it can be seen how the fracture suddenly changes planes in its growth. Also signs of galling are visible near the exterior edge of the implant. Again a smooth surface occupies a large amount which typical for crack growth by fatigue followed by a small region with crystalline morphology where catastrophic failure occurred [21].

In fig. 10.b the crack origin can be easily located by tracing backwards the branched river-lines towards the outside edge of the implant. Aspects of galling can be observed, by compression loading the fractured surfaces were in sliding contact.

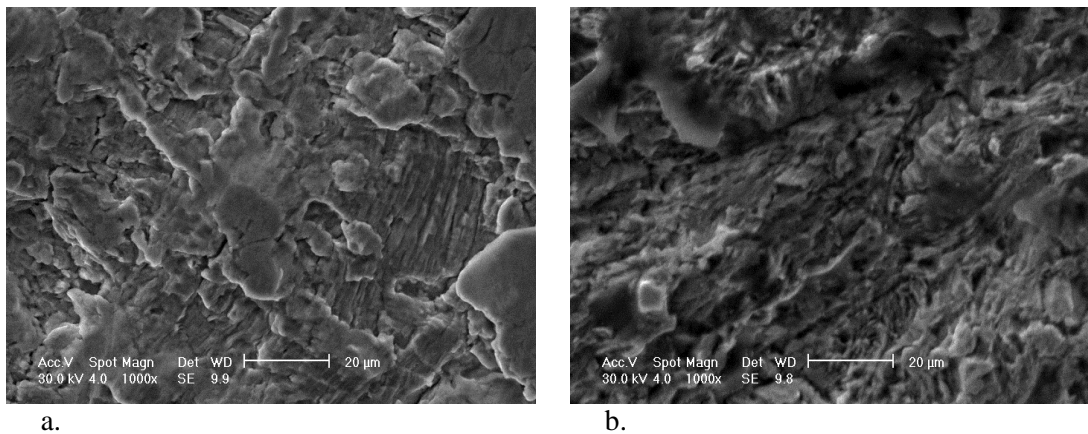
Fig. 11. SEM image showing details from fracture surface with a. galling and micro-cracks and b. cleavage facets

In fig. 11.a details from a galled region are shown, the sliding direction coincides with crack growths on a NE-SV path. Branching micro-cracks can be observed parallel to this direction. In the region studied and shown in fig. 11.b same crack growth direction was observed but no galling was present.

In this case a fatigue bending failure was inferred with the origin of the crack located at implant surface.

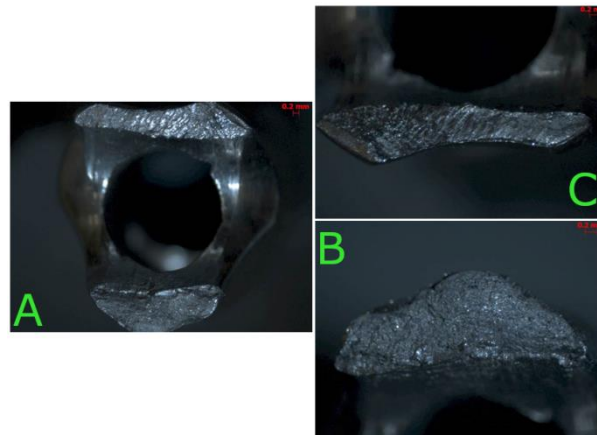
Observations performed using the stereo-microscope on the fractured surface revealed mixed fracture aspects, brittle and ductile, shown in fig. 14.c and predominant brittle failure in fig. 14.b. According to fracture aspects a fatigue failure can be inferred, fatigue striation and river-lines converge to crack initiation site [22] in the NE region of fig. 14.a. The loading which caused the fracture appears to be in bending.

Fig. 14. Fractured implant observed using the stereomicroscope  
a. top view, b. and c. details on the fracture surface

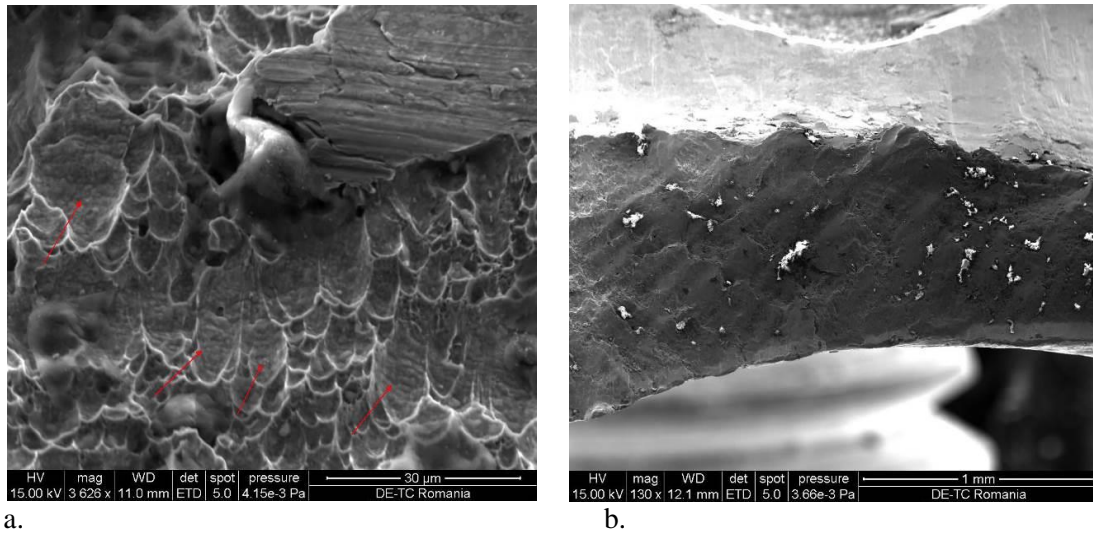
Using the scanning electron microscope fracture site details were observed at higher magnifications and galling can be observed in fig 15.a and b. The arrows point towards crack initiation site. Sliding direction can be observed in fig. 15.b on a NE-SV direction.

a. b.  
Fig. 15. Fracture surface studied using SEM showing a. elongated dimples where ductile fracture occurs and b. galled area

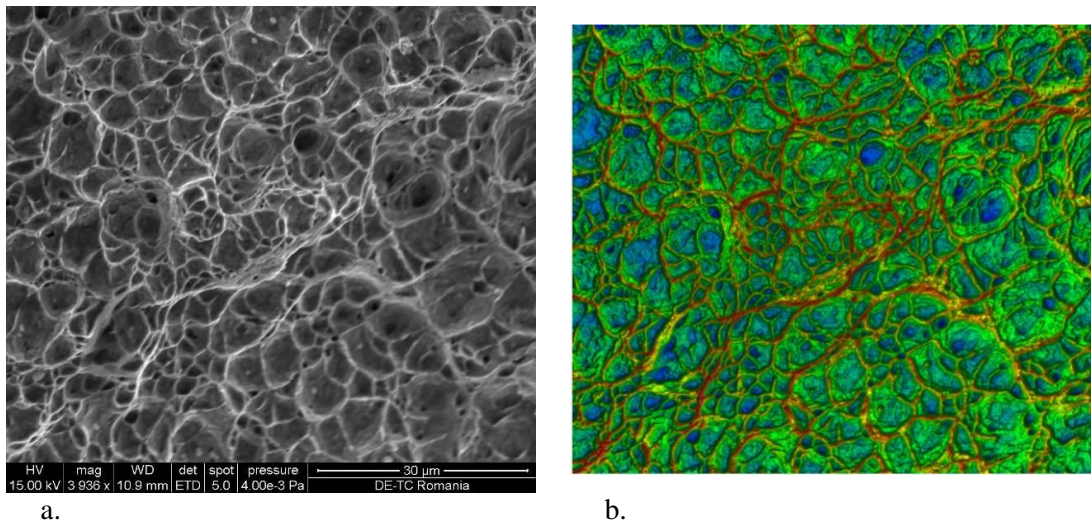
The dimpled aspect presented in fig. 16 is typical for a ductile fracture and voids can be observed at the bottom. The overload causes microvoid coalescence and the elongated dimples seen in fig. 15.a suggest shearing while in fig. 16.a enhanced by artificial height coloring in fig. 16.b dimple morphology suggests a tensile loading.

a. b.  
Fig. 16. Scanning electron microscopy of a fracture surface showing dimples and voids in a. as acquired state and b. artificial coloring by height

The mixed fracture aspects confirm a bending fatigue failure, where a region is loaded in tension and another in compression, while the in-between region shear appears. The crack most likely originated at a defect near the surface, unfortunately galling covered all features that could point the exact initiation site.

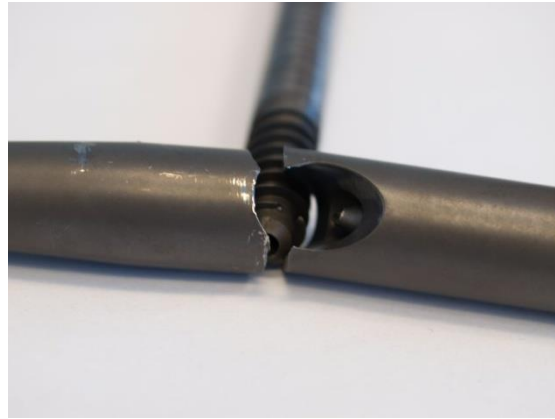
Fig. 17. Failure region of the Gamma nail

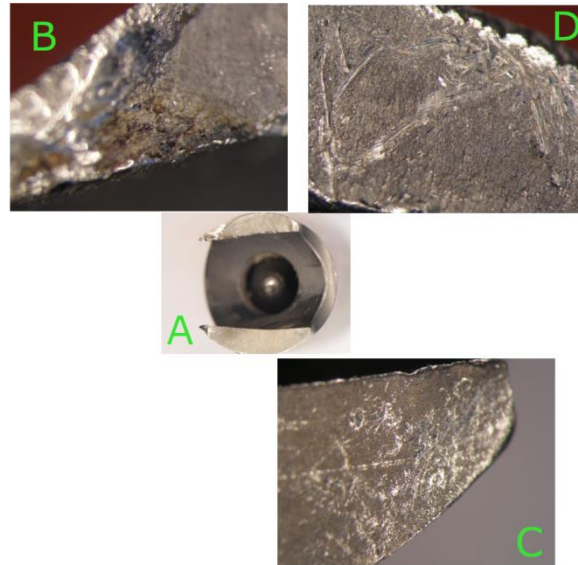
Fracture surface studies were firstly performed using the stereo-microscope, in fig. 19 .a to d. details of the fracture surface are shown. In fig. 19.a fracture surface is observed from a top perspective, the features observed led to a first inference that bending was the main loading type.

Fig. 19. Fracture surface observed using the stereomicroscope where a. shows matching fractured components and b. to d. details from the fracture surface

In fig. 19.b a corroded region was observed along brittle fracture morphology, cleavage planes and steps become obvious in fig. 19.d at higher magnifications. Deep grooves and scratches were created by the physician in his attempt to extract the implant, as observed in fig. 19.c and d.

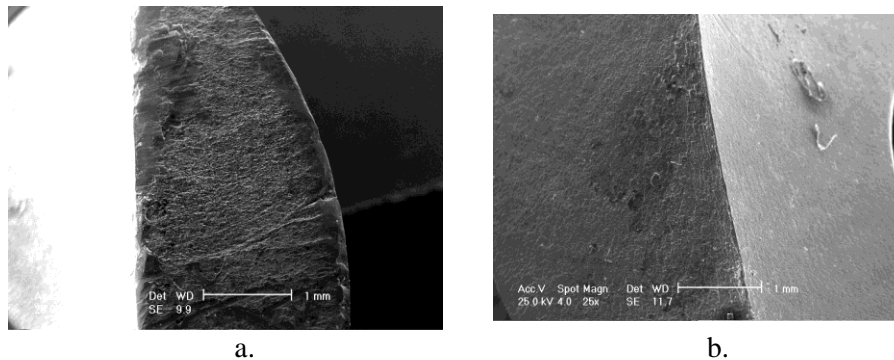
Scanning electron microscopy studies performed on fracture surface revealed fatigue failure aspects observable in fig. 20.a and b. with a crack origin located at the surface, caused most likely by a surface defect [24].

Fig. 20. Fracture surface studied by scanning electron microscopy showing a. near surface crack origin and b. river lines converging towards crack origin

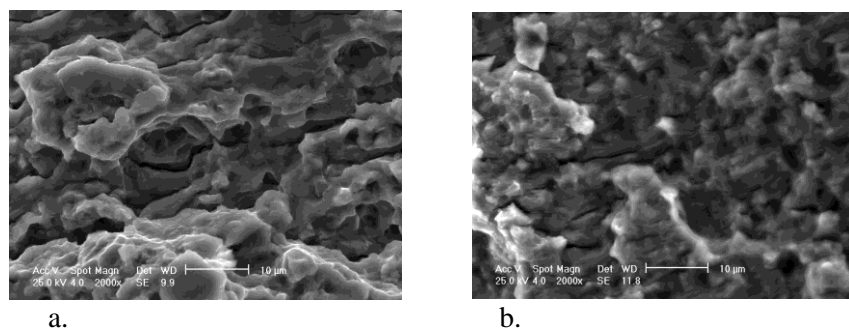
Further fracture surface studies shown in fig. 21.a reveal transgranular cleavage facets with several fatigue striations observable in fig. 21. b.

Fig. 21. Scanning electron micrograph of the fractured surface showing a. transgranular cleavage facets, microcracks and b. fatigue striations on facets

Fine cracks are also observable in fig. 21.a and b which are most likely to originate from alpha phase grains, given its structure and characteristics [23, 25].

The implant failed by fatigue, crack origin was found on the implant region where tensile stresses [26] are dominant.

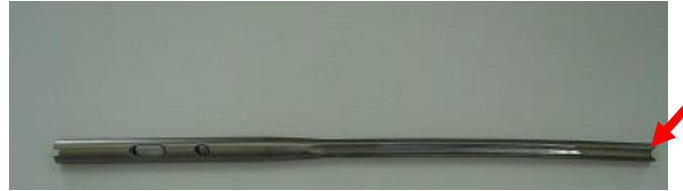
The centromedullary nail shown in Fig.22 was studied given its different loading mechanism when compared with Gamma 3 nail. The failure occurred, as pointed by the arrow in fig. 22 in the distal region, at the hole.

Fig. 22. Studied explant and fracture region

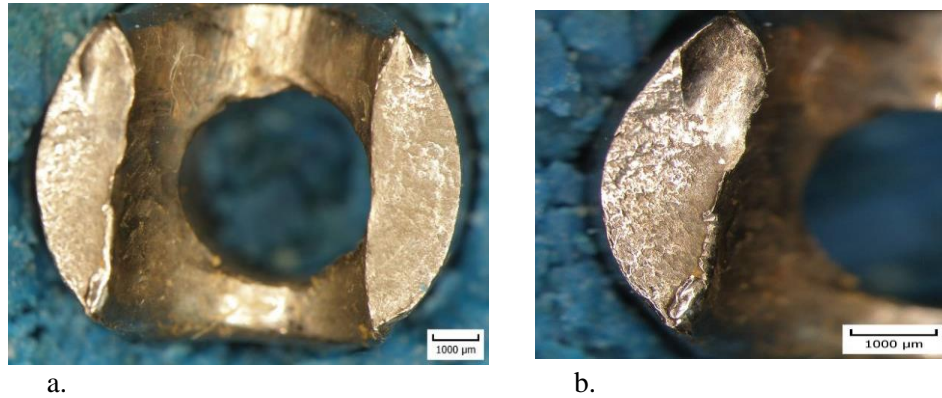
Studies of the fracture surface using the stereomicroscope revealed fatigue failure details similar to those presented in [27] as shown in fig. 24 a. and b. Gallings appears by sliding surface contact in compression, the details are easier to identify in fig. 24.b.

a.  
b.  
Fig. 24. Fracture site study using the stereomicroscope showing a. generic fracture overview and b. detail showing galling

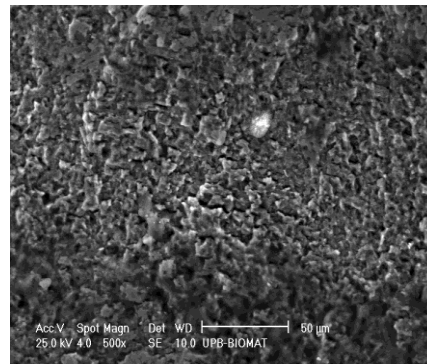
Scanning electron microscopy studies revealed a regions with a faceted fracture appearance, as shown in fig. 25.

Fig. 25. Scanning electron micrograph showing cleavage facets

The failure of this implant occurred by fatigue in by bending.

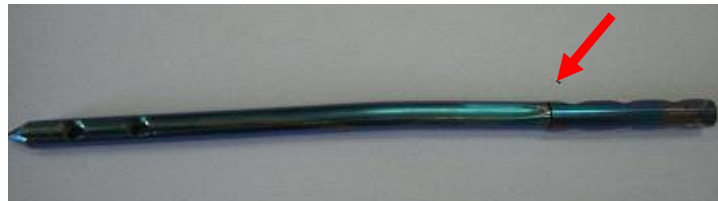
The last failed implant from the titanium alloys series is shown in fig. 26, the failure occurred in the proximal end, opposed to the implant studied previously.

Fig. 26. Failed explant, the arrow points to fracture location

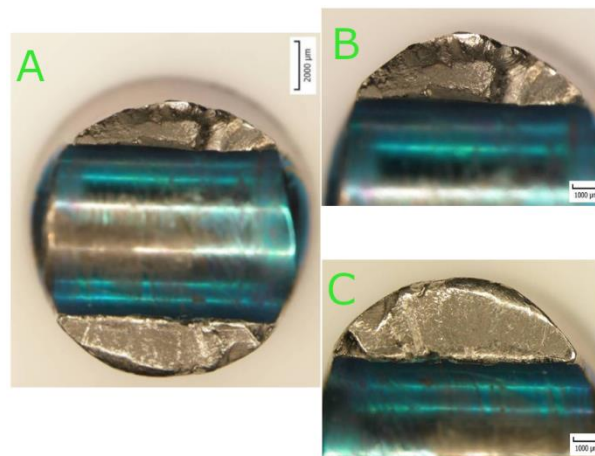
Fracture surface observed using the stereomicroscope revealed fatigue fracture details, as shown in Fig. 28. a, and mixed fracture morphologies specific to ductile and brittle failure are observed in Fig. 28.b and c.

Fig. 28. Fracture surface studied using the stereomicroscope, a. general view, b. and c. details showing fatigue striations and brittle failure aspects

Fracture morphology shown in Fig. 28 suggests a bending load.

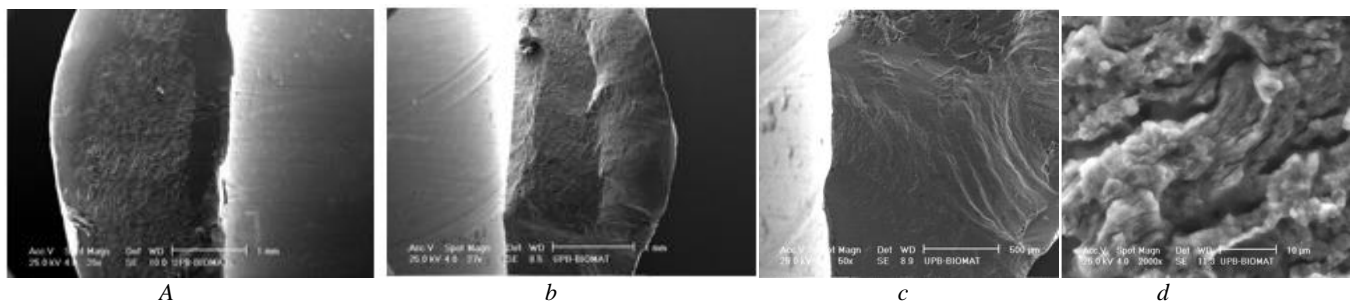
Studies by scanning electron microscopy [28-32] reveal regions galling, Fig. 29.a, fatigue striations similar to those presented in appear and river lines diverge from fracture initiation site observable in Fig. 29.c.

Fig. 29 Fracture surface studied by SEM details in a. showing galling, b. mixed mode of fracture, c. fatigue striations and d. brittle fracture and micro-cracks

Crack growth changed planes resulting in ledges as seen in Fig. 29.b, while a faceted cleavage surface appears with fine cracks oriented in the same direction in Fig. 29.d.

Fracture in this implant was caused by fatigue in bending.
