# Fractography Study of Explanted Intramedullary Nails

*This study comprises the studies performed on six in vivo failed centromedullary fixation devices, three made of stainless steel 316L and three of titanium alloy Ti-6Al-4V. Fractographic studies were performed using stereomicroscopy and scanning electron microscopy while metallographic studies were performed by light microscopy. Loading mode which caused failure was inferred based upon surface fracture topography and light microscopy studies were performed to observe if abnormal microstructures or inclusions could be the cause of the failure. In all cases the chemical composition was according to standard specifications and the microstructures appeared normal with low inclusionary content. The mode of failure was found to be fatigue and the crack initiation site was on the implant surface on roughness features and surface induced defects.*

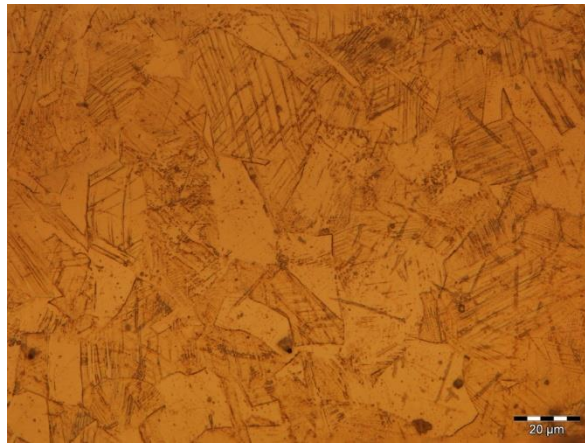
Fig. 2. Optical micrographs showing stainless steel microstructure

The micrograph shown in Fig. 2 shows a typical solid solution with twins suggesting a FCC system, the austenite. The inclusion content determined prior etching established that the steel is clean (low inclusions content) this way a possible cause of failure can be eliminated.

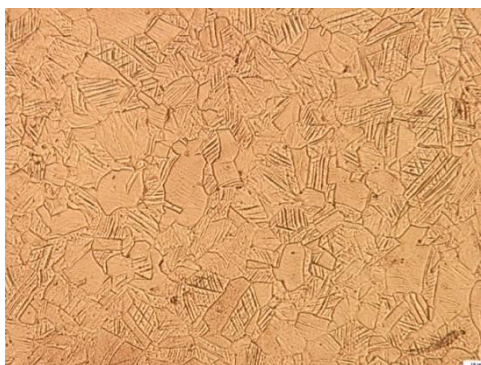
Fig. 8. Optical micrograph showing an austenitic microstructure.

The microstructure shown in Fig. 8 reveals a typical austenitic structure with fine grains and low inclusion content. Regarding the microstructure and inclusion content the steel conforms to specifications for its use.

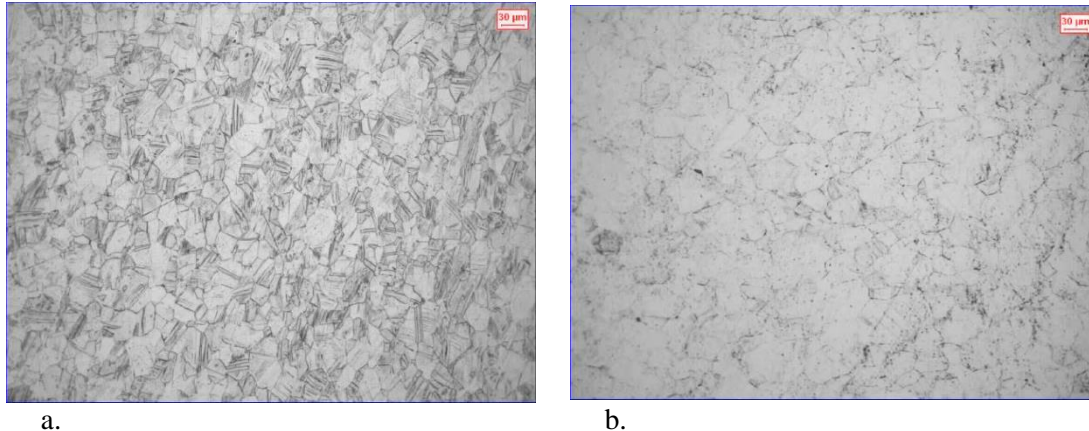
Metallographic specimens obtained from the implant were studied by light microscopy and the microstructure shown in fig. 13.a and b in transverse and longitudinal direction reveals a typical austenitic structure with fine grains and a slight preferred orientation.

Fig. 13. Optical micrograph on the implant on a. transverse and b. longitudinal direction

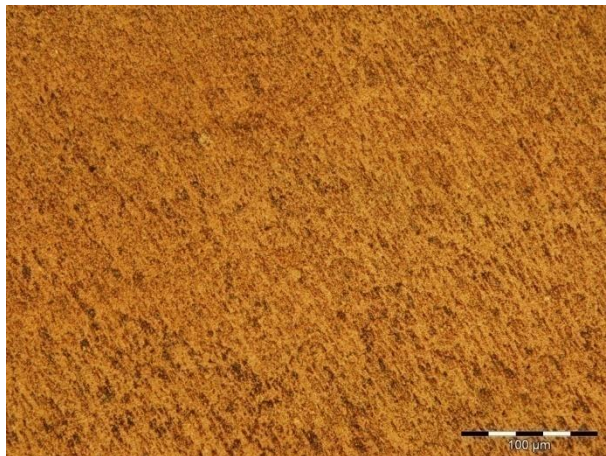
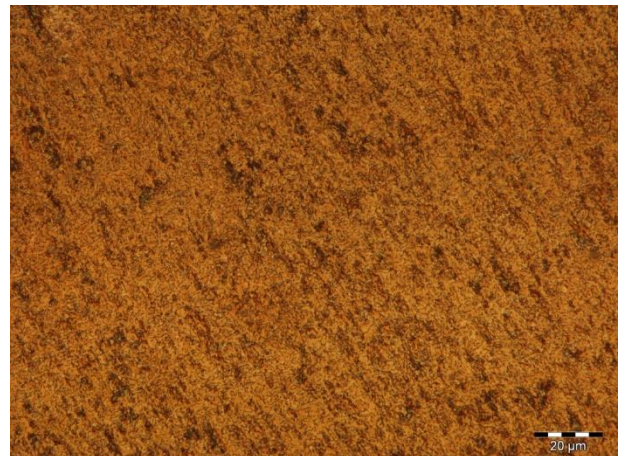
Fig. 18. Optical micrographs showing Ti-6Al-4V microstructures at a. 200X and b. 500X magnification

The microstructures depicted in fig. 18 a. and b. reveal a microstructure comprised of two phases, alpha and beta, specific for this type of alloy. Phase morphology and orientation suggests a texture produced by plastic deformation of the alloy.

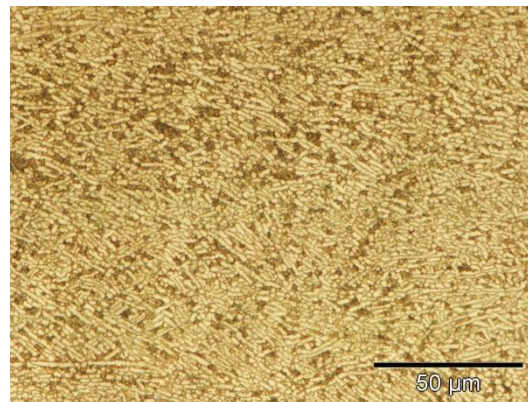
The morphology and distribution of alpha and beta tends towards a bi-modal microstructure resulting from thermo-mechanical processing [23], the lamellar alpha phase is deformed and oriented.

Fig. 23. Optical micrograph showing oriented alpha+beta microstructure

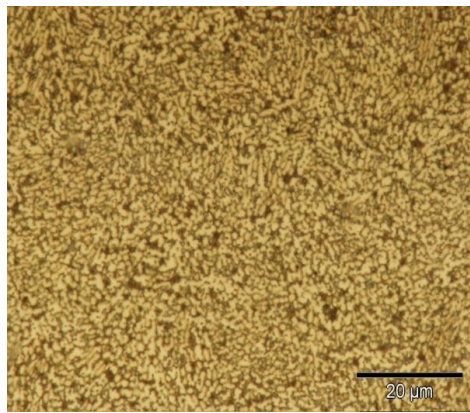
The studies using light microscopy revealed a typical microstructure formed by an alpha and beta phase mixture (Fig. 27 ), typically for Ti-6Al-4V.

Fig. 27. Optical micrograph of the alloy showing a dual phase alpha+beta microstructure

Large inclusions and other in-homogeneities were not observed in the microstructure.
