# New Results Regarding Cavitation Behavior of Polymers Modified with Anorganic Substances Coated on Bronze Surfaces

**Keywords:** polymer, composite material, cavitation, film, layer, pitting, SEM and EDAX analysis

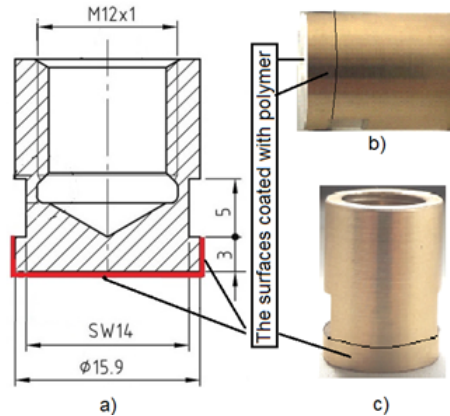
Fig. 1  
Cavitation sample  
- indication to the  
surfaces coated  
with polymer  
films  
a) - section  
through sample;  
b) and c) - real  
sample

For studying the behavior of modified polymers in vibrating cavitation, were used samples, figure 1 of bronze used in pallet and propellers casting. The polymers layers as films, were coated on active and cylindrical surface of samples. The bronze of samples has the following chemical composition: 81.45 % Cu, 14.58 % Sn, 0.3639 % Zn, 1.037 % Pb, 0.6471 % Fe, 0.8489 % Ni, 0.0359 % Mn, 0.077 % Si, 0.0298 % S. In order to identify and analyze the results, the samples were marked with I and II.

The polymer coated on plain surface (the one affected by cavitation) and cylindrical, figure 1, is a mixture whose composition is: 200g epoxydic resin of Epiphen RE4020 +

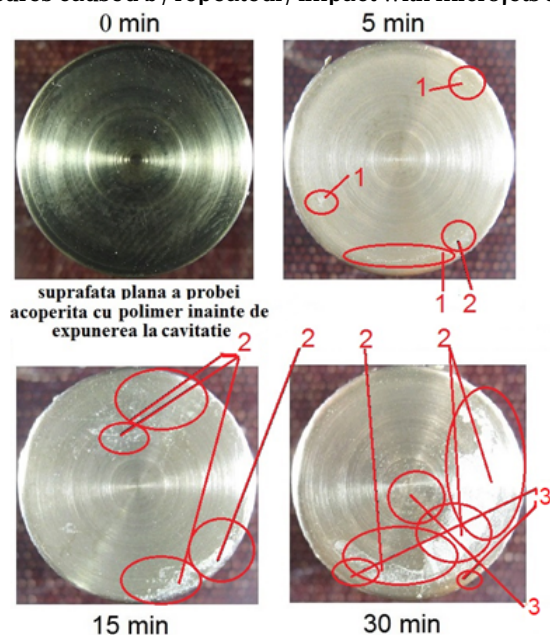
Fig.5 The cavitation behavior of the layers of polymer I  
1. perforations in the polymer film; 2. water and bubbles between the polymer film and the metal surface of the sample; 3. cracks/pittings

The pictures in figure 5-7 show a behavior approximately identical for both samples. In the first 30 min, the behavior of polymer layer in vibrating cavitation, coated on two samples I and II can be seen in figure 5 and figure 6.

- in first 5 min of stress in vibrating cavitation, the layer is very adherent but starts a light detach in periferal zones, but without ripping. From this reason, between polymer layer and metallic surface of sample, due to oscillations, the water penetrated as cavitation bubbles;

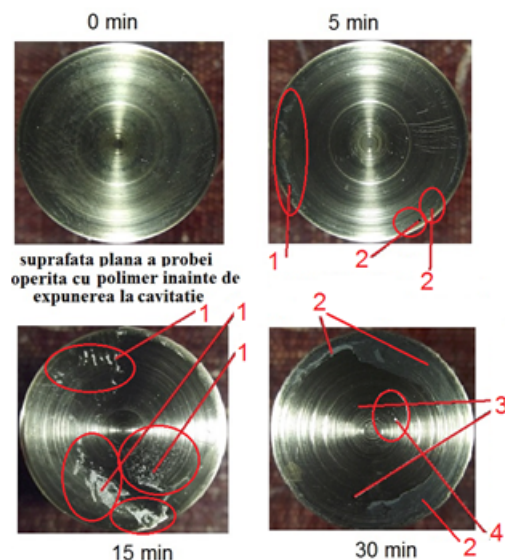
Fig.6 The cavitation behavior of the layers of polymer II  
1. water and bubbles between the polymer film and the metal surface of the sample; 2. the remaining polymer film fixed on the metal surface; 3. expelled polymer film (despoiled surface); 4. cracks/pittings

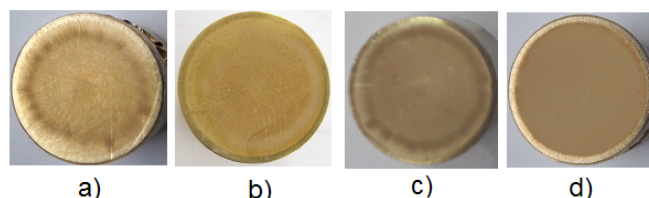
Fig.7 Images of the surface of the sample cavitated  
a) after removal of polymer I film and 45 min of the cavitation exposure; b) after removal of polymer II film and 45 min of the cavitation exposure; c) after 15 min of the cavitation exposure of the bronze surface; d) after 45 min of the cavitation exposure of the bronze surface

- after 45 min of exposure to cavitation, figure 7a and b, can be observed that polymer layers were completely expeled, and metallic surface, under repetitive impact of cavitation microjets, had suffered extensive erosions, more significant on peripheral areas (ring zones dark coloured). Analysis on optical microscope shows the presence of pinches, pitting type, specific for degradation through this type of strain [1].

The comparison with metallic surface degradation evolution without protective layers, figure 7c,d, shows the beneficial effect of polymer layers, that makes, after 45 min of cavitation stress, the coated surface to have less damages (fig.7a, b) than uncovered surfaces after 15 min (fig.7.c) and much more reduced after 45 min (fig.7.d).

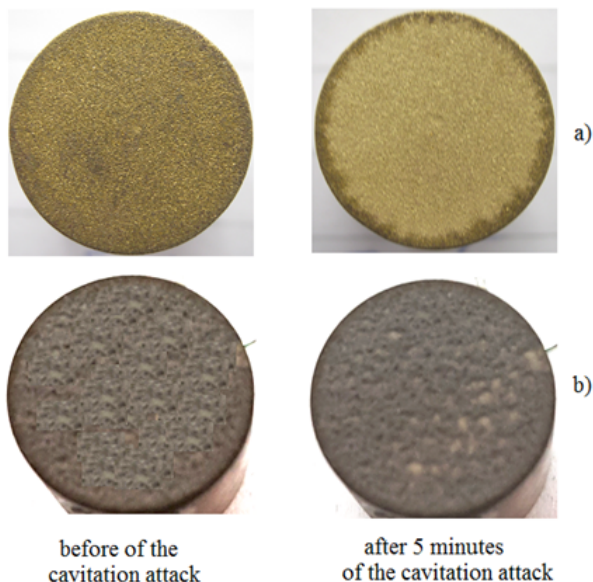
Fig. 8. Comparison of vibratory cavitation behavior between polymer layers and composite material layers HVOF deposited on metallic surfaces . a) composite material with copper base [15] ; b) The Thermico WC-9Co-5Cr-1Ni Ceramic Powder [12]

The comparison with some composite materials layers HVOF coated on carbon steel 270-480 W Sr ISO 13755:1995 ( powder formed of 47.08 %Cu, 28.83 % Zn, 16.2 % Ni, 6.64 % Cr, 0.32 % Ti, 0.27 % PT, 0.27 % Co, 0.22 % Fe, 0.17 % Mo [15]) and stainless steel duplex X2CrNiMoN22-5-3 (ceramic powder Thermico WC-9Co-5Cr-1Ni [12]), figure 8 with important erosions yet from

first 5 minutes of cavitation, it can be stated that modified polymer layers have a superior resistance. As it turns out, the damage is different: composite layers are degraded according to the technique of cavern generation, while in polymer layers, perforations are delayed due to elasticity, but in time, the adherence is decreased and the layer is peeled. These differences represent premises for continuing the research in order to increase the adherence to metallic surface.

The comparison with coated composite materials layers HVOF, figure 8 and with degrading way of unprotected metallic surface, figure 5 and figure 7, suggests the continuing of research in order to create new modified polymers, to lead towards increasing the duration of stress to cavitation such that can be used successfully to coat the surfaces that work in high cavitation intensity currents.
